## Post-eruption sediment budget for the North Fork Toutle River Drainage, June 1980–June 1981

ANDRE K. LEHRE, Arcata, BRIAN D. COLLINS and THOMAS DUNNE, Seattle

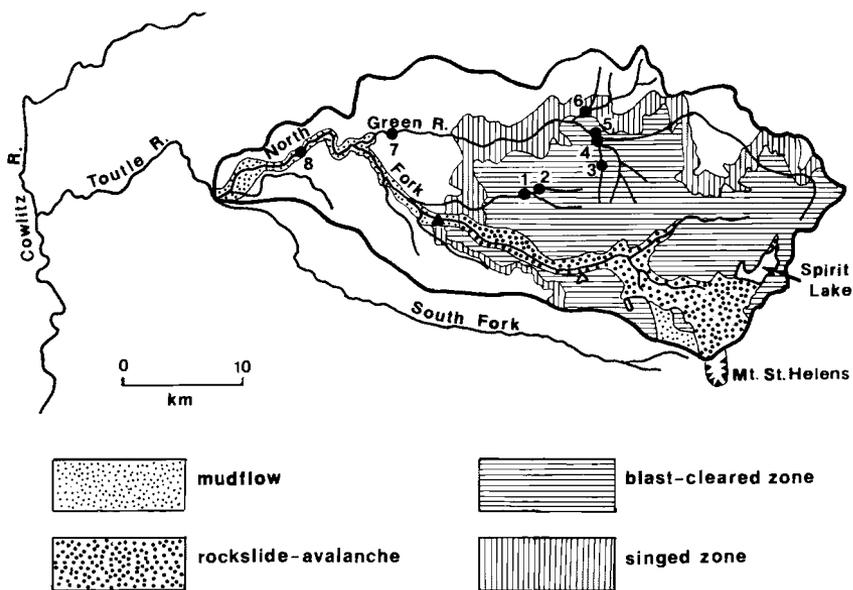
Fig. 1. Effects of Mt. St. Helens eruption on North Fork Toutle River drainage basin. Map shows effects only for areas within North Fork divide (heavy black line). Solid triangle on North Fork indicates position of debris dam (DRS N-1); numbered solid dots indicate stream-gaging sites. Boundaries of mudflow, debris avalanche, blast, and singe zones generalized from U.S. Geological Survey map MF-1254.

The 18 May 1980 eruption of Mt. St. Helens greatly altered the drainage basin of the North Fork Toutle and Green Rivers (fig. 1). The lateral blast destroyed vegetation and deposited up to a meter of gravelly and sandy ash on hillslopes in  $336 \text{ km}^2$  of the drainage north and west of the mountain; subsequent airfall mantled these deposits with 0.02–0.06 m of poorly-permeable silty ash (COLLINS et al. this volume). A massive rockslide-avalanche filled  $60 \text{ km}^2$  of the upper North Fork valley with volcanic rubble 5 to 195 m thick (GLICKEN et al. 1980; VOIGHT et al. 1981). Finally, volcanic mudflows covered the banks and floodplain of the North Fork with 0.5 to 5 m of sand, silt, and gravel.

Table 5. Bedload as fraction of suspended load in blast-area streams. Gaging sites shown on fig. 1.

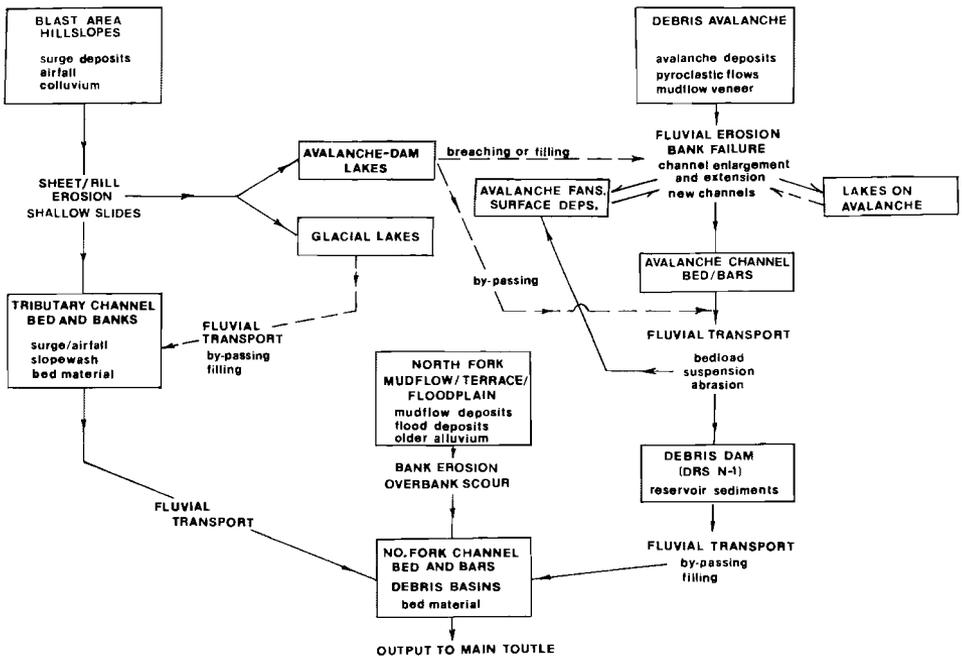
Fig. 2. Conceptual model of sediment sources, transport processes, and storage elements for North Fork Toutle drainage. Boxes indicate sediment sources or storage elements; specific deposit materials are listed in lower-case type. Arrows, labeled with transport processes, show flows between storage elements; lower-case type describes or qualifies transport processes. Broken lines indicate links that may not always be present: e.g., lakes dammed by avalanche may or may not have surface outflow or channel connections. By-passing refers to sediment passing through a storage element as if it did not exist, e.g., fine material being carried through a lake in suspension, or coarser material being carried on through if lake has filled in.

avalanche and pyroclastic flow deposits in the upstream 25 km of the North Fork valley (VOIGHT et al. 1981); and c) mudflow deposits extending downstream along the North Fork from the debris retention dam to the confluence with the South Fork. Figure 1 shows the general distribution of these units. Soil and colluvium underlying the hillslope rephra layer and older alluvium beneath mudflow deposits are currently relatively minor sediment sources. Figure 2 diagrams our conceptual model linking sediment sources, transport processes, and storage elements in the North Fork drainage.

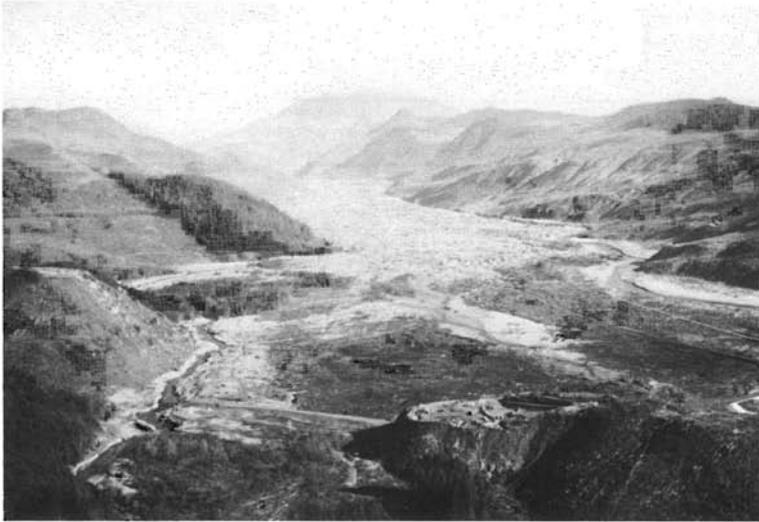
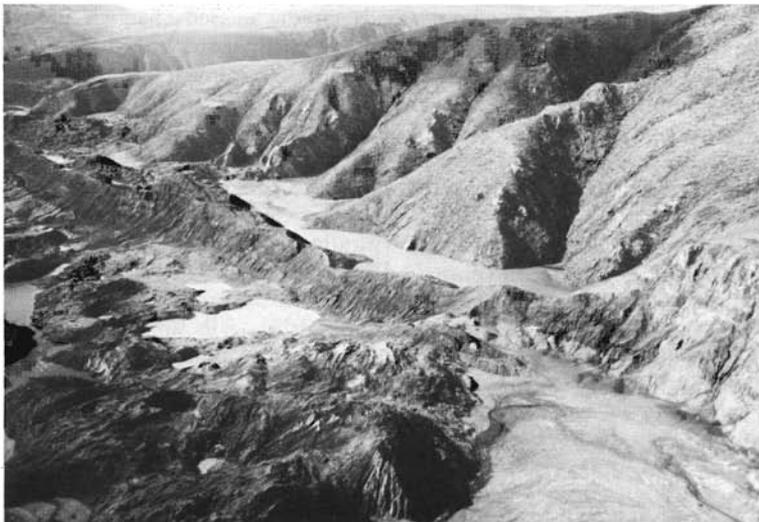
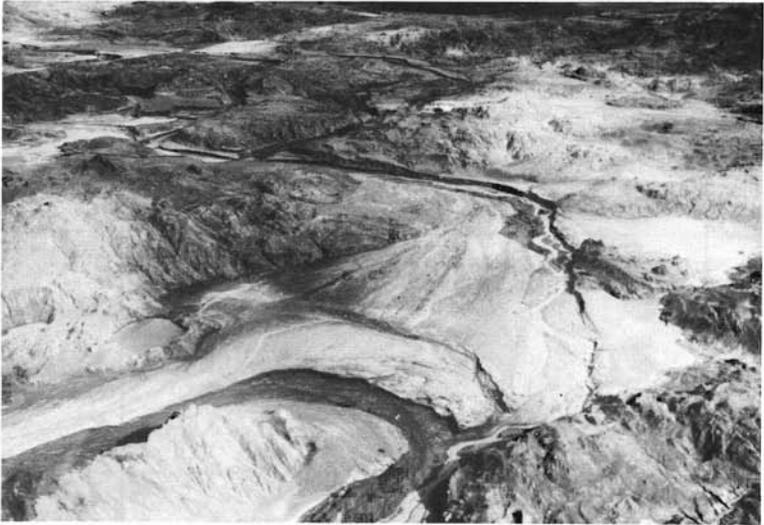
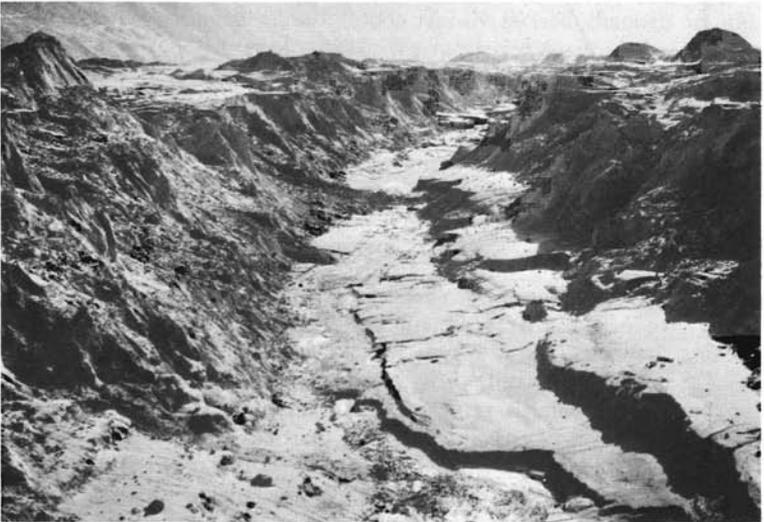
Photo 1. Rockslide-debris avalanche. 1A. Rockslide-debris avalanche terminus viewed from Hoffstadt Mtn. Light-colored, hummocky slide deposits extend from Mt. St. Helens (background) to mid-photo; mudflow deposits extend downstream from terminus along right and left margins of valley. 1B. Lakes on avalanche by Coldwater Ridge. Those at base of ridge are drainages impounded

by avalanche levees; those on avalanche surface occupy ice-melt collapse and subsidence pits. 1C. Alluvial fan on avalanche surface formed by lake-outburst floods. 1D. Canyon cut in easily-erodible avalanche deposits by May 18 mudflow and later floods. Walls are 25–30 m tall.

Spirit Lake down the valley of the North Fork to approximately 1 km upstream of the North Fork debris retention dam (photo 1a). Average depth of avalanche deposits covering the 1–2 km wide valley floor is 45 m; total deposit volume is estimated at  $2500 \times 10^6 \text{ m}^3$  (GLICKEN et al. 1980; VOIGHT et al. 1981). Mean size distribution of avalanche deposits (table 1) is 40% gravel and boulders, 45% sand, and 15% silt and clay; VOIGHT et al. (1981) find 43%, 42%, and 15% respectively. Mean dry-bulk density of deposits ranges from 1.7–1.8  $\text{g/cm}^3$  (VOIGHT et al. 1981). An estimated  $150\text{--}200 \times 10^6 \text{ m}^3$  of pyroclastic flow deposits (MACLEOD et al. 1980; ROWLEY et al. 1981) mantle the north slope of the cone and eastern end of the avalanche. Grain size and thickness data available to us were not sufficient to permit separate calculation of the erosion of pyroclastics; we therefore lumped them together with the avalanche deposits.

Channels and gullies on the debris avalanche are typically steepwalled trapezoidal slots 3–50 m deep and 3–120 m wide at bottom (photo 1d). Channel walls commonly slope at 30–45°, and may be as steep as 70°. Channels widen by bank undercutting and failure during high flow; evidence of slumps, debris slides, and debris falls are common on channel walls. Bank recession is most rapid where the channel is braiding extensively; between October 1980 and March 1981 mean width of the south marginal channel doubled from 60 to 120 m.

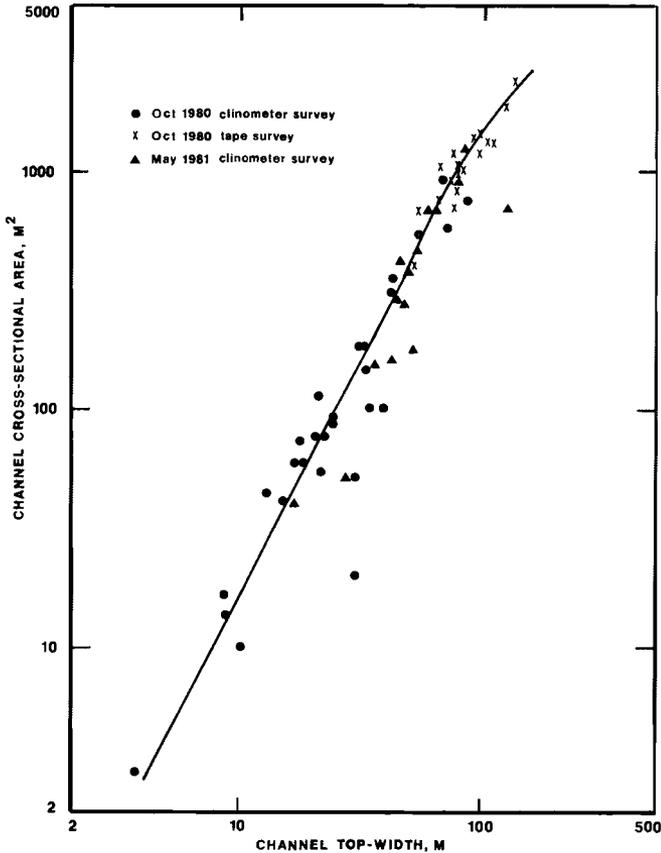
Fig. 3. Relation of top-width to cross-sectional area for channels on debris avalanche. Line of relation was fit using 1980 data only; good fit to 1981 data indicates stability of relation. Channels plotting far to right of line (2 points) have experienced significant filling.

Table 2. Volume of channels on debris avalanche. Volumes computed from airphoto measurements of channel width and width-area relation of Figure 3. Channels on 19 June photos were created chiefly by mudflows and floods of 18–19 May.

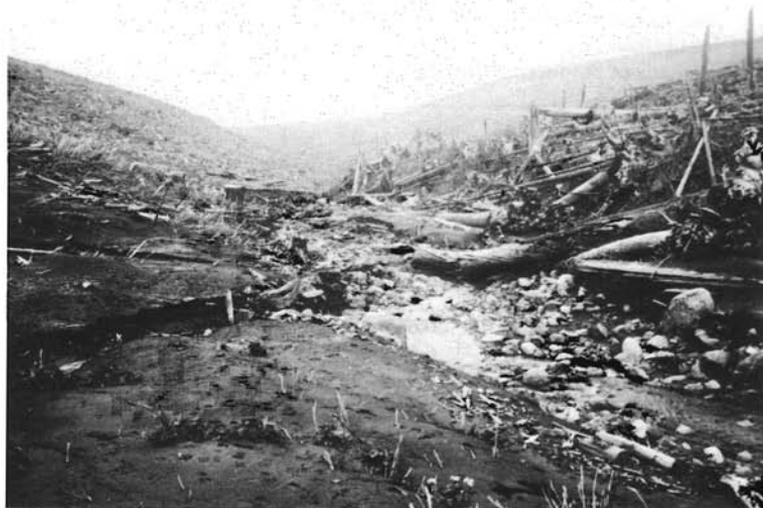
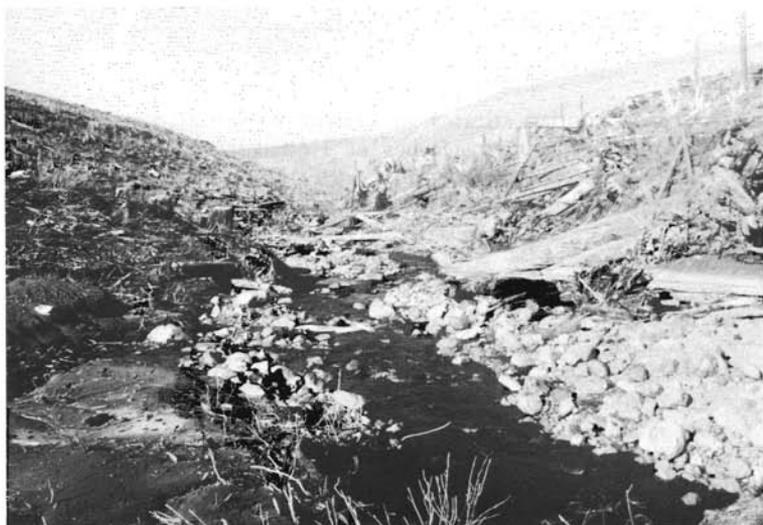
Photo 2. Shultz Creek, a blast-affected tributary to the Green River. 2A. View downstream from Main Shultz XS 1 before first winter storms (30 Oct. 1980). Note extensive tephra cover along right bank. 2B. Same view on 13 March 1981. Tephra cover has been removed extensively along right bank and channel gravels are far cleaner. Exposure of buried woody debris on left bank shows tephra eroded upslope has not accumulated on footslopes.

Nearly all stream reaches in table 4 experienced net erosion. Channels generally widened more than deepened; this commonly reflected a) scour to bedrock or boulders (Hoffstadt Cr., W. Fork Shultz XS 7-8), b) local filling by gravelly debris torrent deposits (Main Shultz Cr. XS 0-8), or c) easy erosion of banks in surge deposits (W. Fork Shultz XS 1-5). Our measurements suggest that material eroded from hillslopes is not generally accumulating on footslopes or in tributary channels, but is instead being carried out to the major rivers. This hypothesis is supported qualitatively by sequential photographs of stream reaches taken from monumented points. These show progressive coarsening of the bed, removal of tephra deposits on banks, and no systematic buildup of sediment around logs and stumps on footslopes (photos 2a, b).

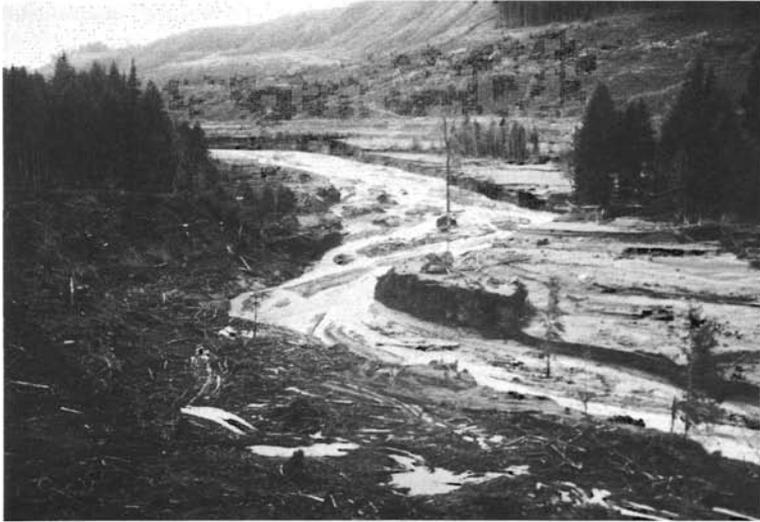
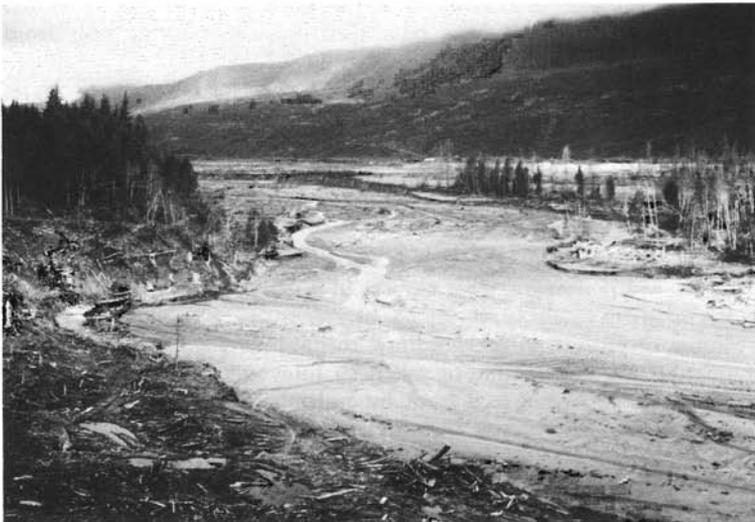
Photo 3. Erosion of mudflow affected channel, North Fork Toutle River near Camp Baker. 3A. View downstream on 25 November 1980, after first major winter storm. 3B. Same view 15 March 1981. Channel has at least doubled in width and has aggraded extensively.

Between June 1980 and March 1981 the North Fork channel generally doubled or tripled its width. Greatest width changes were associated with extensive bar formation and braiding in wide, low-gradient reaches (photos 3 a, b).

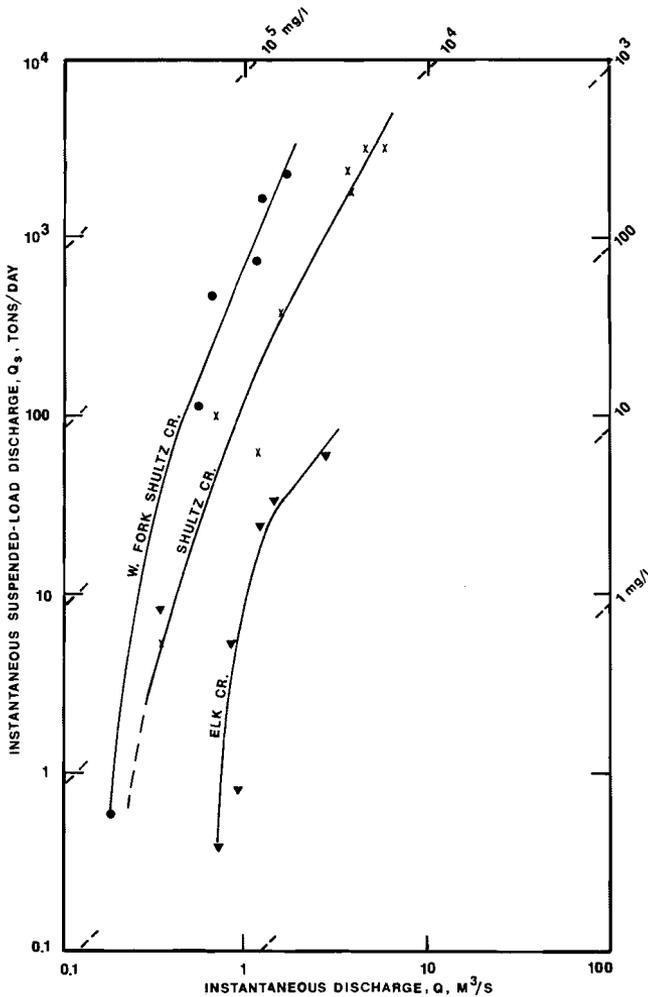
Fig. 4. Suspended-sediment rating curves for blast-affected and relatively unaffected streams. W. Fork Shultz Cr. ( $A=7.7 \text{ km}^2$ ) and Main Shultz Cr. ( $A=29.8 \text{ km}^2$ ) drainages lie entirely within blast zone; Elk Cr. ( $A=29.6 \text{ km}^2$ ) drainage is undisturbed except for  $6.6 \text{ km}^2$  (22%) in singe zone. Diagonal marks indicate concentrations in mg/l. For equivalent flows, suspended-sediment concentrations on Elk Cr. are an order of magnitude less than those on Shultz Cr.

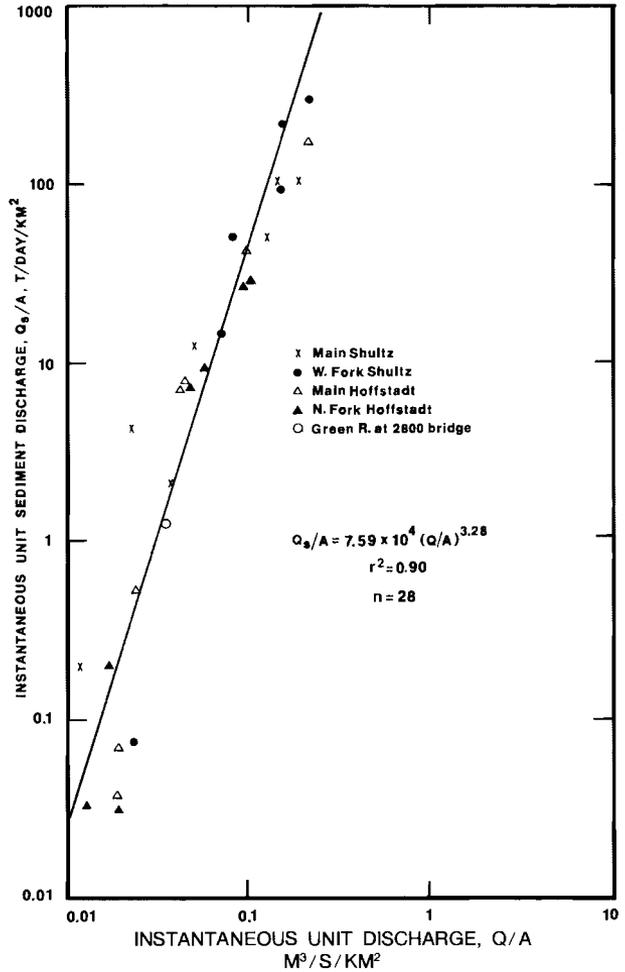
Fig. 5. Unit suspended-sediment transport curve for blast-affected streams. Samples taken December 1980–March 1981. Water and suspended-sediment discharge have been regionalized by dividing by drainage area (A).

We estimated suspended-load discharge from blast-area streams by means of a unit suspended-sediment transport curve derived from our samples (fig. 5) in combination with adjusted flow-duration data from the U.S. Geological Survey Green River gaging station (fig. 6). Bedload, taken as 22% of suspended load, was added to yield total load. These load estimates range from 43% (Shultz Cr.) to 101% (Green R.) of the amounts we estimated were contributed by hillslope and tributary channel erosion (table 6). The

closeness of load and slope erosion estimates on the Green River is gratifying but probably partly fortuitous; more puzzling is the disparity between the two on Shultz Creek, where we have good control on both slope erosion (COLLINS et al., this volume) and changes in channel storage (table 4). We believe that the discrepancy in estimates arises largely from: a) hillslope erosion had already begun to decline markedly prior to the period when data was collected for construction of the sediment-rating curve (December 1980–February 1981); b) estimation of bedload as a simple percentage of suspended load (this probably grossly underestimates its contribution at high discharges); c) inadequate knowledge of the sediment rating curve for flows higher than those measured; d) possible delivery of large volumes of sediment to main channels by debris torrents (suggested by two sediment discharge measurements at the U.S. Geological Survey Green River gage which lie 1 to 2 orders of magnitude above the mean transport curve of fig. 5); e)

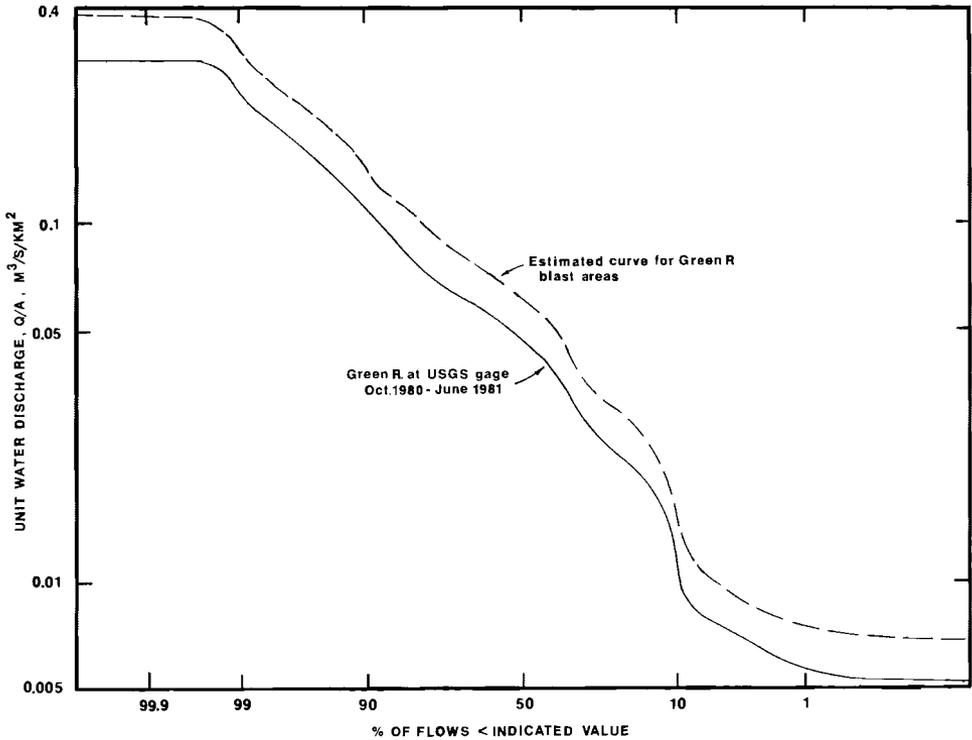
Fig. 6. Unit flow-duration curve for Green River at U.S.G.S. gaging station, 1 October 1980–30 June 1981. Estimated relation for blast-affected areas (dashed line) derived from Green River curve by assuming that blast areas contribute twice as much water per unit area as areas of standing timber, a ratio suggested by comparison of flows on Elk and Shultz creeks. Discharges have been regionalized by dividing by drainage area. Upper curve was used in sediment discharge calculations discussed in text. Gaging station is at # 7 on fig. 1.
