Erosion of tephra from the 1980 eruption of Mount St. Helens

BRIAN D. COLLINS } Department of Geological Sciences and Quaternary Research Center, University of Washington, Seattle,
 THOMAS DUNNE } Washington 98195

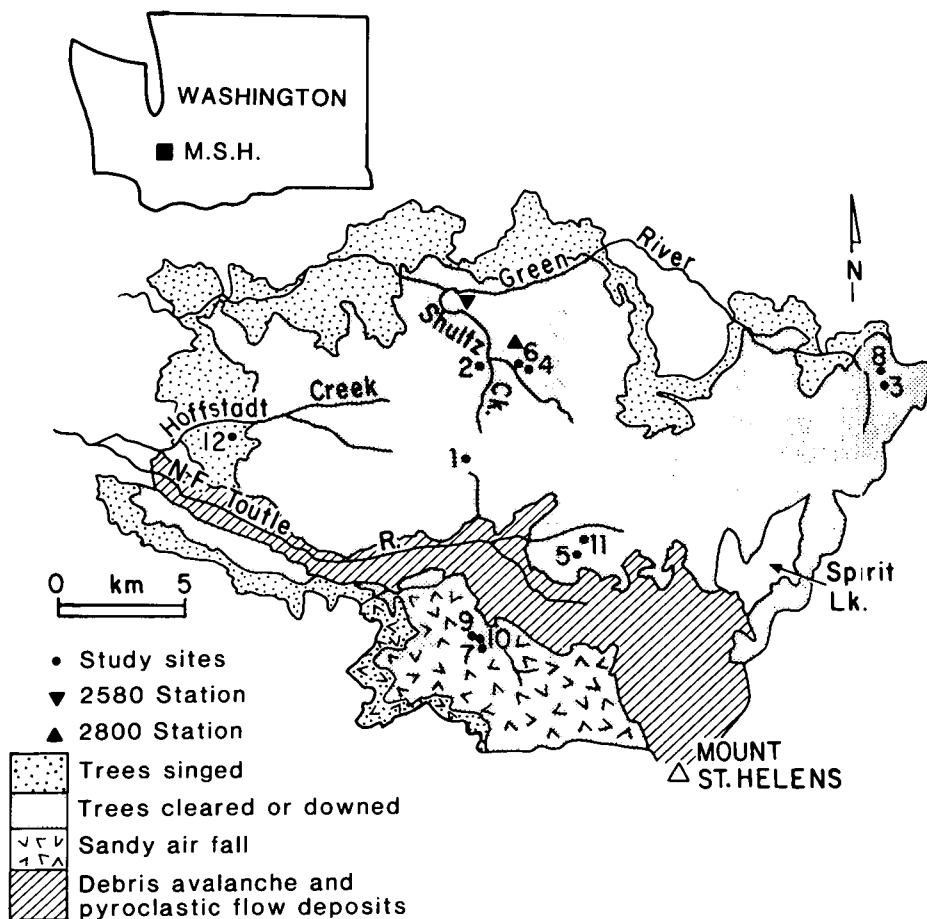
Figure 1. Location of tephra-covered hillslopes studied. Numbered locations refer to Table 1.

Air-fall tephra from numerous pyroclastic flows and from vertical, magmatic eruptions later on May 18 and subsequent dates fell atop the deposits of the blast. Only the eruption on May 25, however, deposited an appreciable thickness of tephra over much of the Toutle River catchment (Sarna-Wojcicki and others, 1981), covering the southwestern part of the blast-affected area (Fig. 1) with a sandy layer 2 to 10 cm thick (Fig. 2b).

The eruption radically altered the hillslope hydrology by removing the forest vegetation from large areas and by depositing a blanket of tephra over the permeable topsoil (Fig. 1). In August 1980, Herkelrath and Leavesley (1981) measured infiltration capacities of 1–5 mm/hr on silty air-fall tephra in the basin of Shultz Creek. Rainfall intensities measured during the

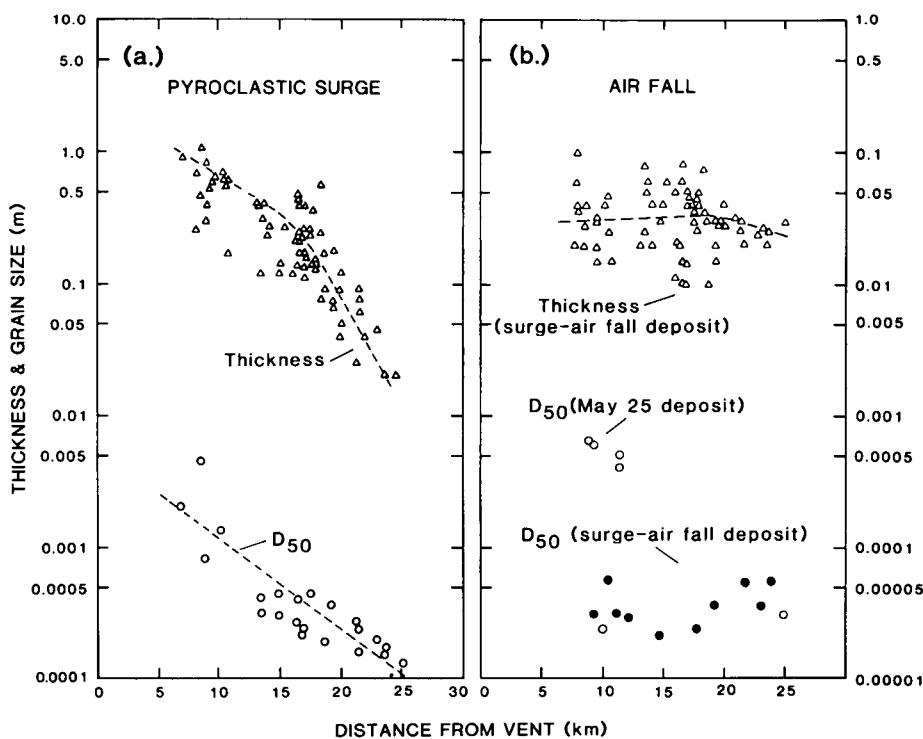
Figure 2. (a) Variation of median grain size (D_{50}) and thickness of the pyroclastic-surge deposit (excluding the air-fall unit) with distance from the volcano. (b) Grain size and thickness of the air-fall layer associated with the pyroclastic surge and grain size of the May 25 air-fall layer. Thickness of the May 25 layer (not shown) plots within the field defined by the surge-related air-fall layer (data indicated by filled symbols are from Hoblitt and others, 1981).

The median grain size of the pyroclastic-surge deposits decreased with distance from the vent from ~1 mm at 10 km to 0.2 mm at 25 km (Fig. 2a). The deposit thickness decreased with distance from the vent, from 1.0 m at 10 km to 0.02 m at 25 km, and varied with the topography, thinning to zero on the steepest slopes at all distances from the volcano. This effect was greatest near the volcano, where the tephra layer was thick on moderately to gently sloping ridges and hillsides and thin or absent on the glacially eroded, steep lower slopes. The samples shown in Figure 2a do not represent these very steep slopes.

relatively constant throughout the area affected by the blast (Fig. 2b); its thickness immediately after the eruption ranged from ~1 to 10 cm and averaged 3–4 cm.

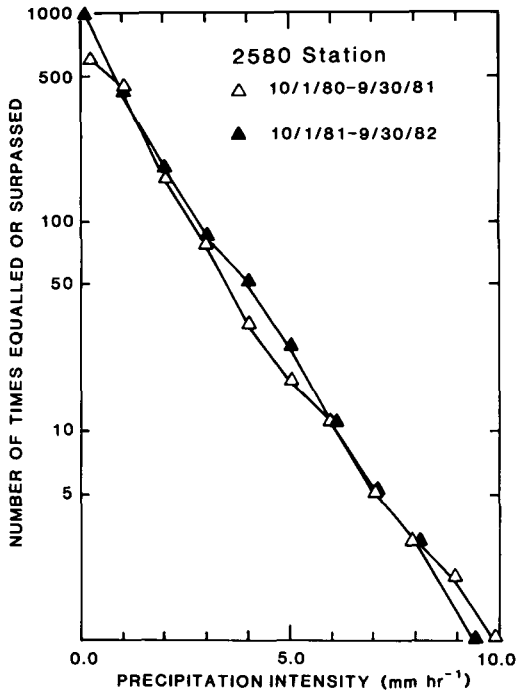
Figure 3. Intensity and frequency of precipitation in 1-hr intervals at the 2580 station (from data provided by Weyerhaeuser Company).

first posteruption year (Fig. 3) indicate that these infiltration capacities were exceeded frequently. We often observed overland flow on the tephra surface between September and November 1980 while installing erosion stakes.

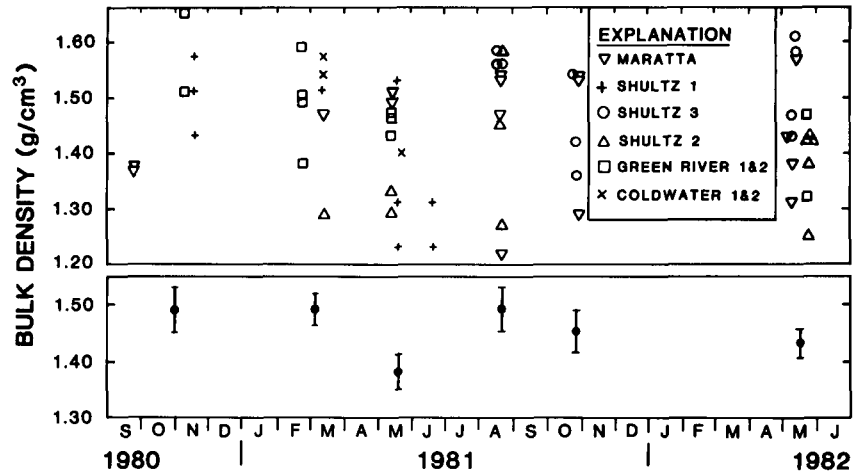
Figure 4. Bulk density of the upper 108 mm of undisturbed tephra at individual sites and mean and standard error of data from all sites. Samples were collected in a 73-mm-diameter cylinder with a 1-mm-wide lip.

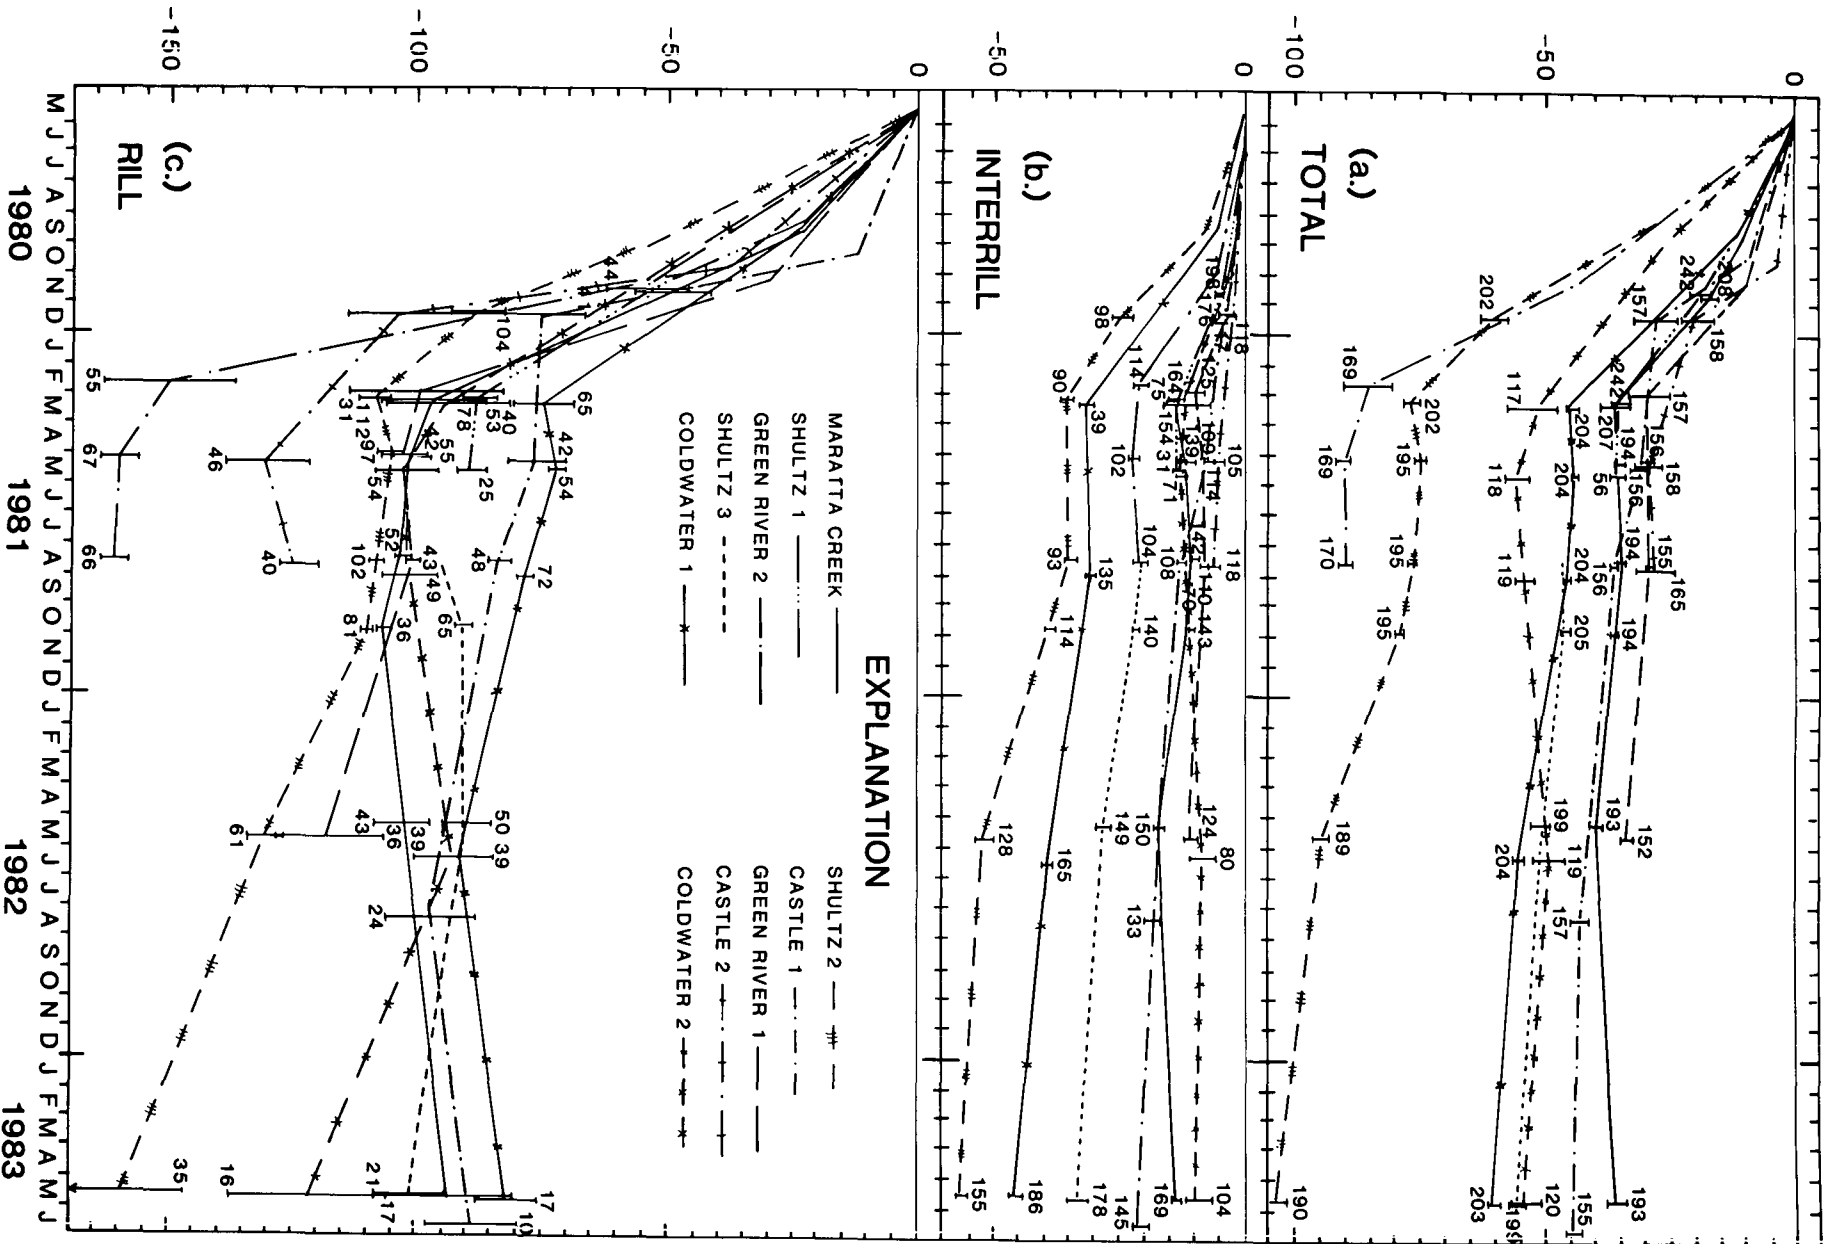
Figure 5. (a) Cumulative mean change in surface elevation of study sites. Error bars show one standard error of the mean. Numerals are the number of stakes in the sample, which changes on some sites because of loss or disturbance of stakes. Lowering prior to stake installation was taken as the sum of rill cross-sectional areas plus an estimate of sheetwash erosion from the regression analysis of data by Collins (1984). The standard errors range between 0.5 mm and 5.9 mm and average 2.0 mm. The Castle 3 site (not shown) exhibited mean lowering of 19 ± 6.3 mm ($n = 121$) between 25 October 1980 and 25 August 1981. (b) Cumulative mean change in interrill surface elevation with one standard error of the mean and sample size at each site. Lowering on the Castle 3 site between 25 October 1980 and 25 August 1981 was 0.2 ± 2.5 mm ($n = 86$). (c) Cumulative mean change of surface elevation in rills, showing one standard error of the mean and sample size. Lowering on the Castle 3 site was 66 ± 19 mm ($n = 35$) between 25 October 1980 and 25 August 1981.

Figure 5a shows the cumulative mean change of surface elevation on the study sites. The changes represent the combined erosion of tephra and underlying colluvium. The temporal patterns of interrill and rill erosion are discussed separately below.

The cumulative mean lowering of interrill surfaces is shown in Figure 5b. The figure displays the same over-all changes in rate of lowering shown by the rills (Fig. 5c, discussed below), although the decline is less rapid. This decreasing rate of change is due in part to an increase in the infiltration rate of the interrill surface. Infiltration experiments conducted in 1980 by Herkelrath and Leavesley (1981) were repeated in 1981 on 2 plots within the Shultz 1 site and showed that the infiltration rate had increased from 1-5 mm/hr to 7-9 mm/hr (G. H. Leavesley, personal commun.). The experiments were done on large plots that averaged the infiltration rates in rills and divides. Our measurements along one stake transect on the steeper plot

Figure 5c shows that rills incised rapidly during the first ten months after the eruption (until February 1981) and at a sharply decreasing rate thereafter. Many rills stopped incising after reaching the buried soil, because the highly permeable, dense root mat on the soil surface absorbed water and reinforced the soil surface. Some of the larger rills penetrated this mat and incised the underlying soil (for example, Fig. 6). The depths of the largest rills were eventually limited on the steepest slopes by bedrock at depths of 1–1.5 m, except on thick, Holocene tephra layers where rills as deep as 2.5 m reached weathered, cohesive horizons.

The filling and complete obliteration of small rills are reflected in Figure 5c by the decline with time in the number of stakes at rilled localities;

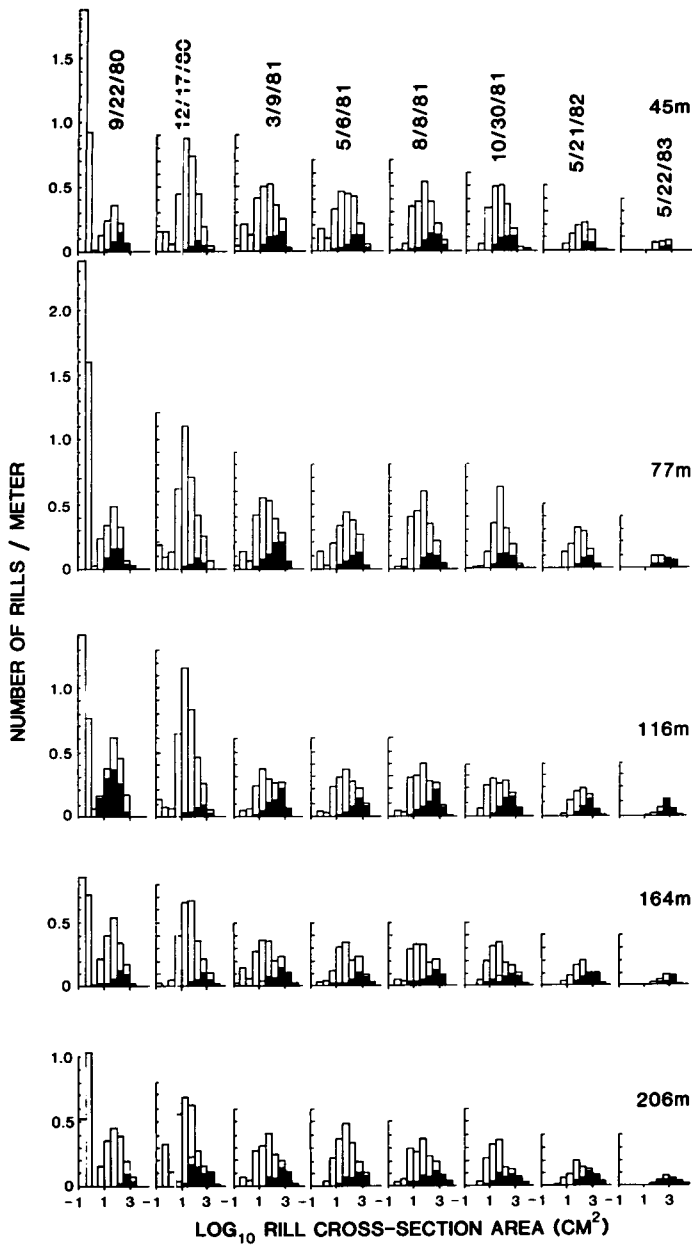
Figure 6. Frequency distribution of rill cross-sectional areas (cm^2) for the Shultz 2 site. Frequency distributions in half- \log_{10} increments are shown for each of five transects measured on eight occasions. Distance from the divide is indicated on the right-hand side for each transect. The rills are divided into those incised into tephra only (unshaded) and rills incised into the buried soil (shaded). Histograms represent 15,336 sets of width and depth measurements.

As the beds of the rills were being lowered, important changes took place in the channel network. Figure 6 shows the frequency distribu-

tion of cross-sectional areas of rills along five transects on a typical hillslope. At the beginning of measurements, many small rills crossed each transect. In September 1980, the average density of rills with cross-sectional areas less than 1 cm² was 1.6–4.0/m, and this density declined rapidly to zero over the following year. Three years after the eruption, all rills with cross-sectional areas less than 31.6 cm² had been eliminated. Apart from these smallest rills, however, the modal area of rills in tephra remained between 18 and 100 cm² throughout the measurement period at all distances downslope, except at the time of the last measurement, when only some of the largest rills remained.

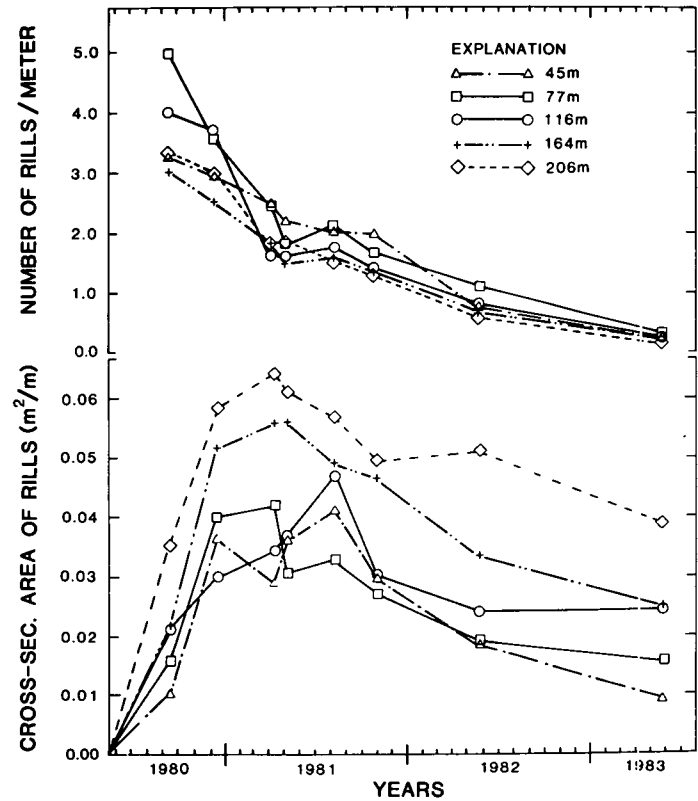
Figure 7. Variation with distance downslope and time of the number of rills per metre of transect and the sum of cross-sectional areas of rills on the Shultz 2 site.

High drainage densities developed soon after the eruption during low-intensity rains with small drops, which are typical of the Pacific Northwest. Such rainstorms on steep surfaces that had exceedingly low infiltration capacities would generate high shear stress for sheetwash but relatively low amounts of rainsplash. Dunne (1980) proposed, and Dunne and Aubry (1986) confirmed experimentally, that rills should form under such conditions in a manner close to that described by Horton (1945) for sheetwash acting alone. In the early stages of network development, larger storms could cause both an increase in the sizes of rills (Fig. 7) and overtopping of drainage divides between rills, leading eventually to the cross-grading and micropiracy proposed by Horton (1945, p. 333) as a means of reducing drainage density (Fig. 7).

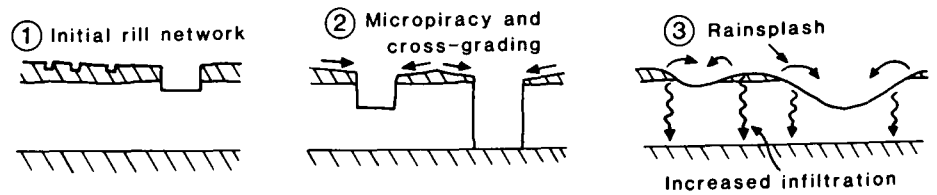
Figure 8. Schematic evolution of a stable rill network. 1. Early storms with a low intensity and small drop size falling onto an impermeable surface gave rise to a dense network of small, subparallel rills with a rectangular cross section. 2. Later, larger storms brought about a decreased drainage density due to micropiracy and cross-grading. Incision of larger rills was limited by the less erodible and more permeable buried soil. At the same time, infiltration capacity on divides increased due to the stripping and alteration of the silty air-fall layer. 3. As a result of these changes, rainsplash became dominant over rillwash and sheetwash, filling or obliterating rills and giving rise to a smoothed surface with convex divides between rills.

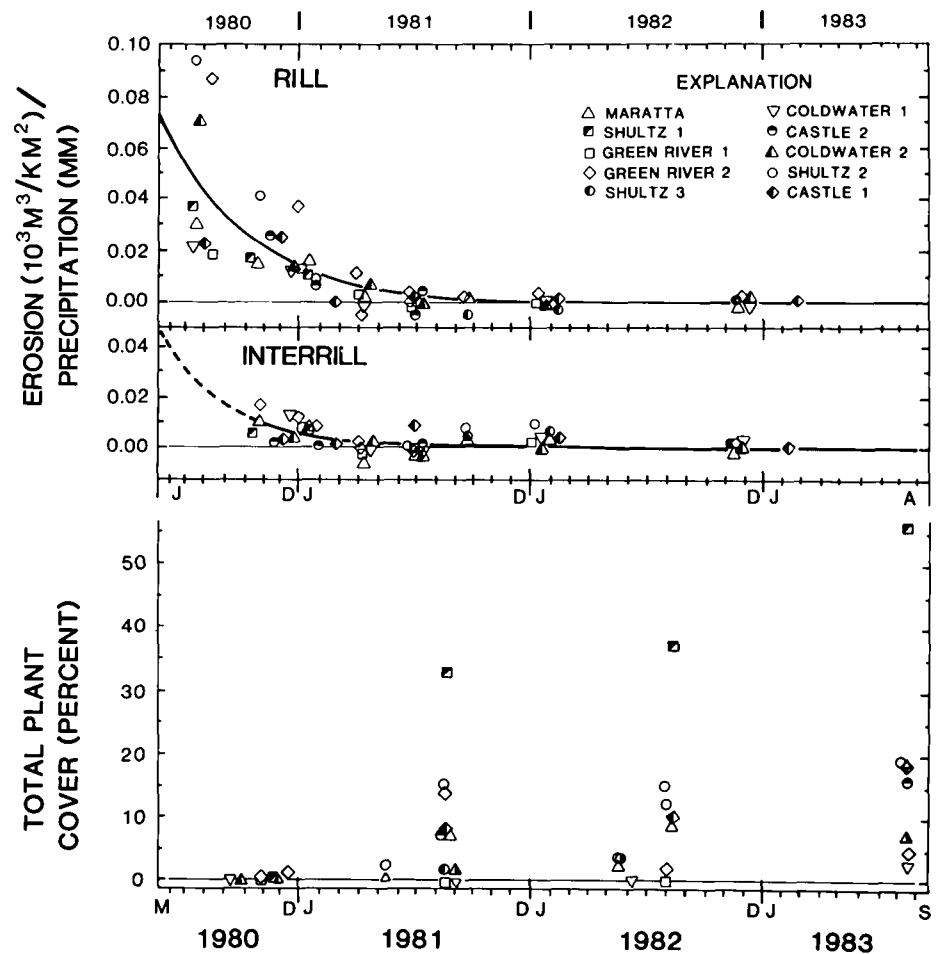
Figure 9. Erosion per unit of precipitation at all sites versus time since the eruption, for rills ($y = 0.073e^{-0.0072x}$, $R^2 = 0.57$) and interrill surfaces ($y = 0.046e^{-0.0091x}$, $R^2 = 0.32$), where x is days after the May 18 eruption and y is erosion in millimetres normalized by millimetres of precipitation. The timing of the decline in erosion is compared to that of changes in total cover provided by native and seeded plants.

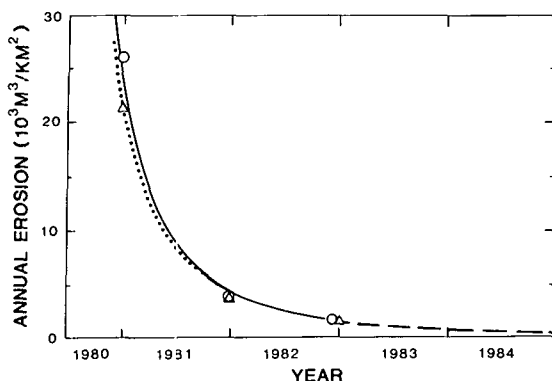
Figure 10. Measured and projected annual erosion of tephra and colluvium (circles and solid curve) and of tephra alone (triangles and dotted curve) for the Toutle River basin during the period 1980–1983 and the projected rate of erosion for 1980–1984. The regression equation for tephra and colluvium is $y = 8.0 \times -1.7$ and for tephra alone is $y = 7.5 \times -1.6$.

Figure 10 shows the declining erosion of tephra and colluvium (circles and solid line) and of tephra alone (triangles and dashed line) for the Toutle River catchment. A power function fitted to the three points for tephra erosion, when projected into the future, predicts an average erosion rate of 0.5 mm/yr ($700 \text{ t/km}^2/\text{yr}$) for 1984–1985 and of 0.1 mm/yr ($140 \text{ t/km}^2/\text{yr}$) for 1989–1990. Integrating under the curve for tephra alone yields erosion of $39 \times 10^3 \text{ t/km}^2$ (28 mm) in 1980–1982, $42 \times 10^3 \text{ t/km}^2$ (30 mm) between 1980 and 1990, and only 700 t/km^2 (0.5 mm) from 1990 to 2000.

The curves do not include effects of land management. Scarification and logging practices used on parts of the basin would reduce erosion 0.2 mm (280 t/km^2) between 1980 and 1990. The curves are also extrapolated from rates that were measured prior to widespread recovery of plants, and it is likely that further growth in coming years will reduce the over-all erosion rate more than Figure 10 predicts (B. D. Collins and T. Dunne, unpub. data).

Neglecting effects of management and plant recovery, Figure 10 predicts that only ~.5% of the tephra on hillslopes will be eroded by sheetwash and rill erosion before soil creep and other forms of mass wasting once again dominate sediment production.
